SITE EVALUATION REPORT

*Proposed Mainland Access Treasure Island,
Lake Waseosa*

CHAFFEY WARD, TOWN OF HUNTSVILLE
DISTRICT MUNICIPALITY OF MUSKOKA

MAY 2019

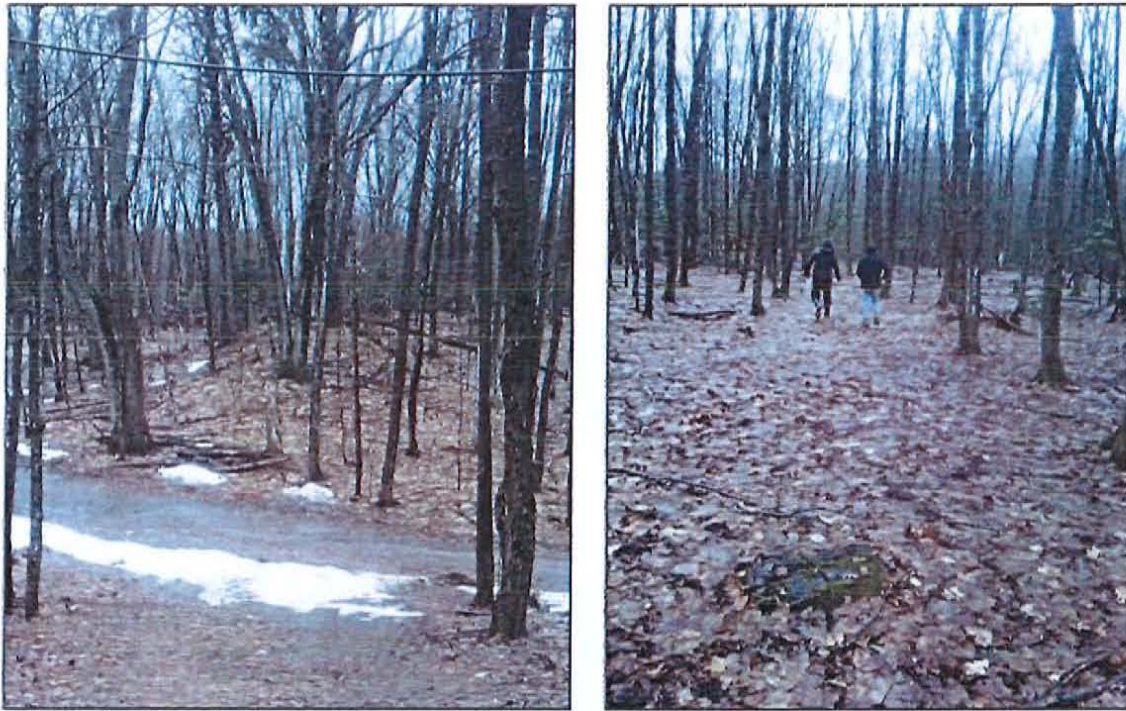
Part 4 is located to the east of the private drive (Part 3) accessing the seasonal dwellings at 622 (Part 1) and 600 (Part 5) North Waseosa Lake Road. Part 4 consists of an upland maple hardwood forest with gradual elevation changes and sandy soils (Photo 1). A wood pole transmission line crosses through parts 1, 3, 4, and 5 of the property as mapped in Figure 1 (Photo 2). The maple hardwood vegetation community is contiguous through Part 5 moving south (Photo 2) towards the shoreline. Approximately 80m upland from the shoreline of Lake Waseosa, the maple hardwood vegetation community transitions to a coniferous ecosite predominated by eastern hemlock, balsam fir, and white birch.

Photos 1 and 2: Left - existing private driveway accessing Lots 600 & 622 North Waseosa Lake Road; Right - upland maple hardwood ecosite

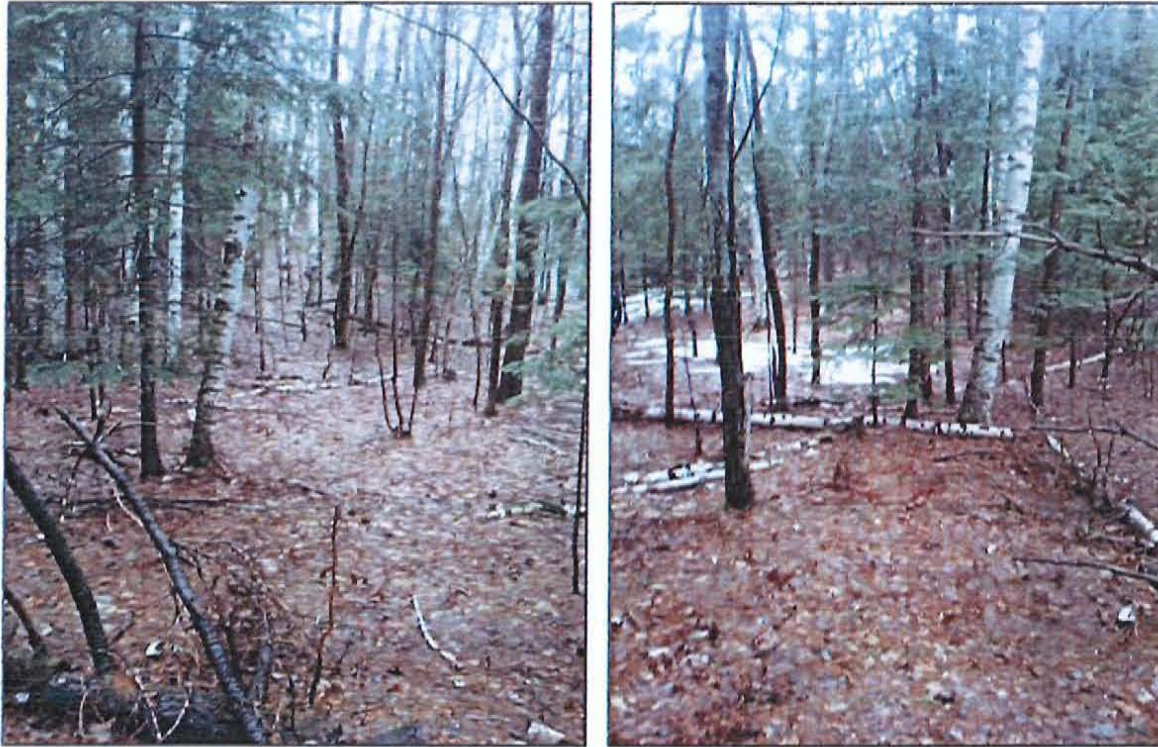
A parking and staging area is proposed on level ground setback 20m from the high-water mark of the lake. The envelope identified during the site visit encompasses an existing natural forest opening in a tall treed ecosite predominantly consisting of eastern hemlock, balsam fir, and white birch. The additional clearing required to accommodate this facility will largely include the removal of thin (<50cm diameter at breast height) trees (Photos 4 and 5).

Photos 4 and 5: Representative photos of existing vegetation contained within the identified construction envelope; Left: taken facing east; Right: taken facing north

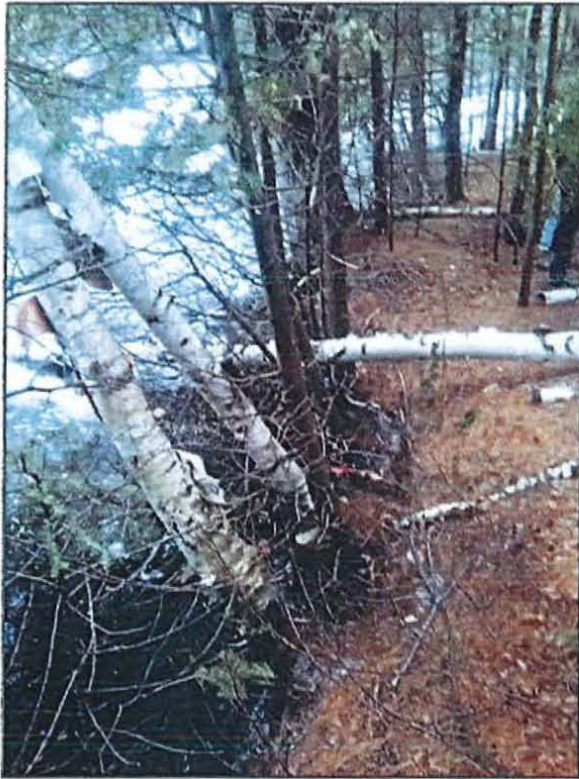
A boat launch ramp with a maximum width of 9.5m is proposed to be located beside a narrow floating dock structure, no greater than 2.5m in width at the shoreline. The shoreline is suitable to accommodate the proposed launch and dock facilities and will be located outside of any sensitive or specialized fish habitat. The gentle, level topography and natural vegetation will serve to limit erosion potential and a porous gravel surface treatment has been proposed for both the access road and parking area. Further, the parking and launch area will be setback over 50m from any existing dwellings, whereby the retained natural vegetation to the north and south will serve to screen and buffer the launch site and associated activity from the existing neighbouring residential properties. It is recommended that all existing vegetation within the riparian zone (20m from Lake Waseosa) is maintained outside of the <12m of shoreline clearing required for water access.

Photos 6 and 7: Representative photos of existing shoreline vegetation in the location of the proposed boat ramp and dock; Left: taken facing north; Right: taken facing west, Treasure Island on the horizon
